## INTRODUCCIÓN A LA NUEVA FORMA DE TASACIÓN URAR (UAD 3.6) APLICACIÓN PRÁCTICA Y MANEJO

TASADOR ENRIQUE M. FERRER URBINA

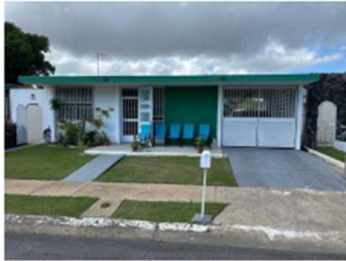
**Dwelling Exterior Exhibits****Dwelling Front**

| Feature | Detail | Quality Comment | Condition Status | Condition Comment |
|---|---|---|---|---|
| Exterior Walls and Trim | Concrete Block Poured Concrete | Standard Grade | Typical Wear and Tear | Adequate |
| Foundation | Poured Concrete Slab | Standard Grade | Typical Wear and Tear | Appear Adequate |
| Roof | Concrete<br>Estimated Age: 20 or more years | Standard Grade | Typical Wear and Tear | Adequate |

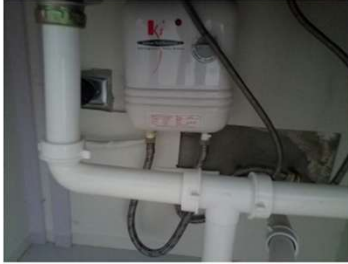
Itemized List of Repairs - Mechanical System - Water Heater was installed

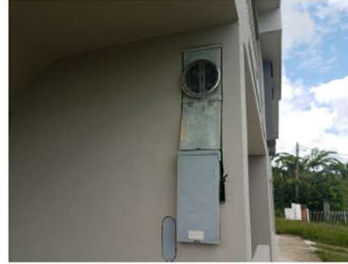
New Observed Items for Repair - Mechanical System - Power Meter was removed
